11. TITLE (Include Security Classification) Corrosion Phenomena During Overcharge in Polymer Electrolyte Cells					
12. PERSONAL AUTHOR(S) M.Z.A. Munshi, R. Gopaliengar, & B.B. Owens					
13a. TYPE OF REPORT Technical		13b. TIME COVERED FROM 7/15/85 TO 5/30/88		14. DATE OF REPORT (Year, Month, Day) May 1988

Corrosion Phenomena During Overcharge
in Polymer Electrolyte Cells

M.Z.A. Munshi
R. Gopaliengar
B.B. Owens

Department of Chemical Engineering and Material Science
Corrosion Research Center
University of Minnesota
221 Church St. SE
Minneapolis, MN 55455
USA

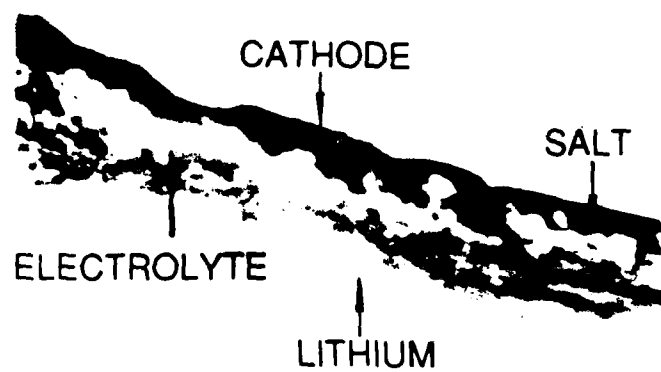
Figure 4. Cross-sectional view of cell #1

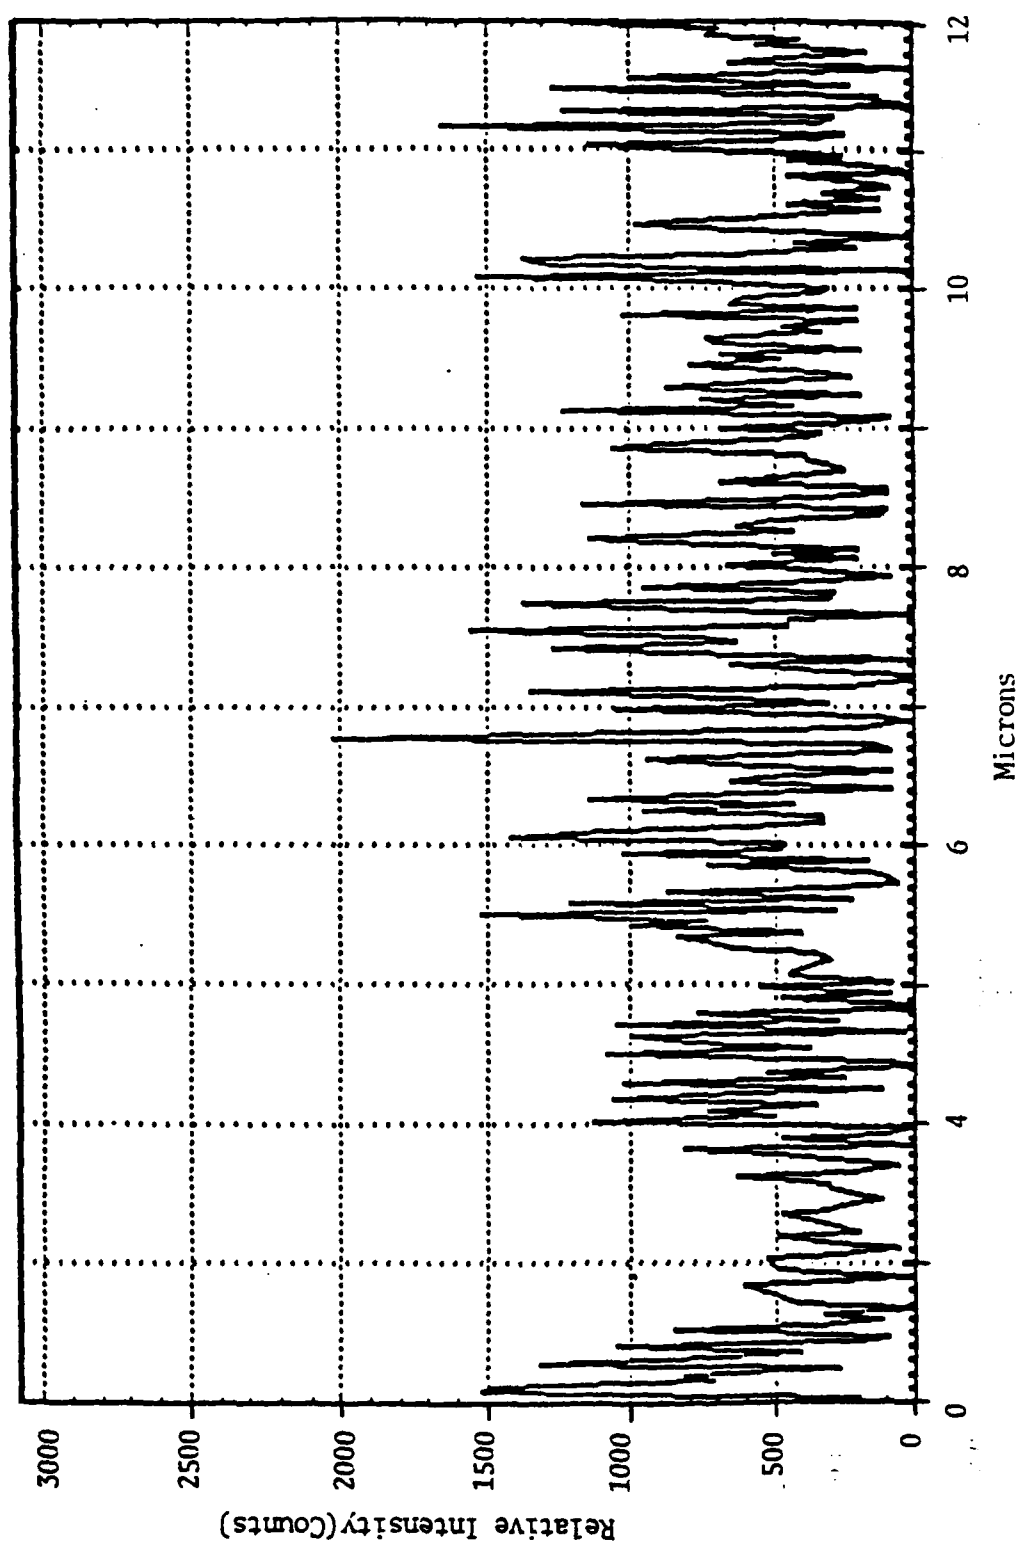
Auger microprobe analysis was made on the electrolyte cross-section for vanadium. Figure 8 shows such a scan indicating vanadium to be present virtually throughout the electrolyte.

Figure 8. Auger microprobe line scan across the electrolyte cross-section for vanadium.

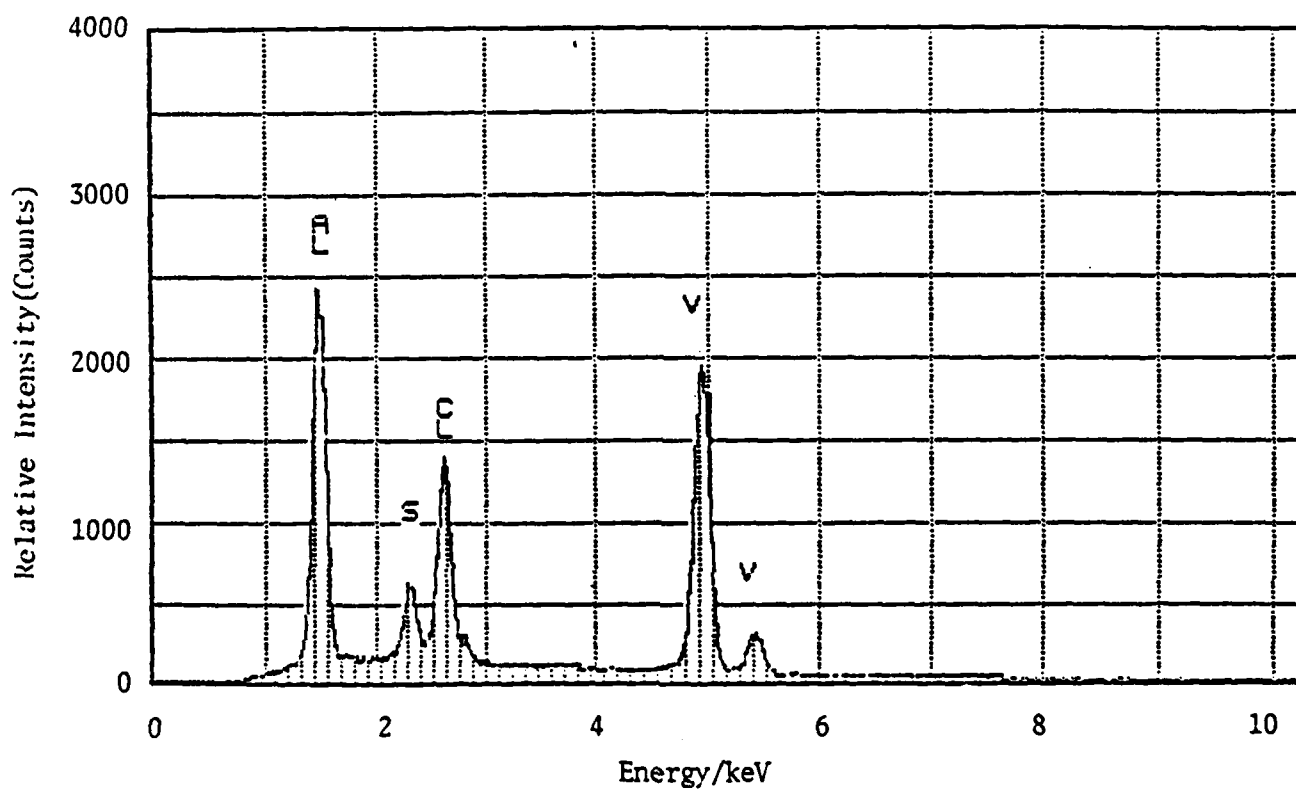
analysis of this surface indicated the presence of Al, Cl, S and V (Figure 12). A Cl x-ray map of this surface revealed that the Cl was situated in localized areas (Figure 13). More remarkable was that the Al was also only present in these same localized clusters (Figure 14). It is well known that Al has a strong affinity for Cl, but the presence of both elements in the same region may just be coincidental.

Figure 12. EDAX analysis of the lithium surface (cell # 4).

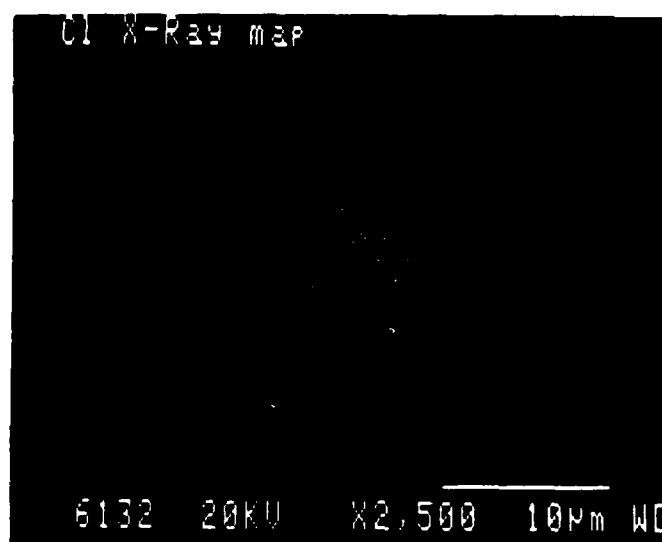
Figure 13 X - ray mapping of Cl on the lithium surface (cell #4).

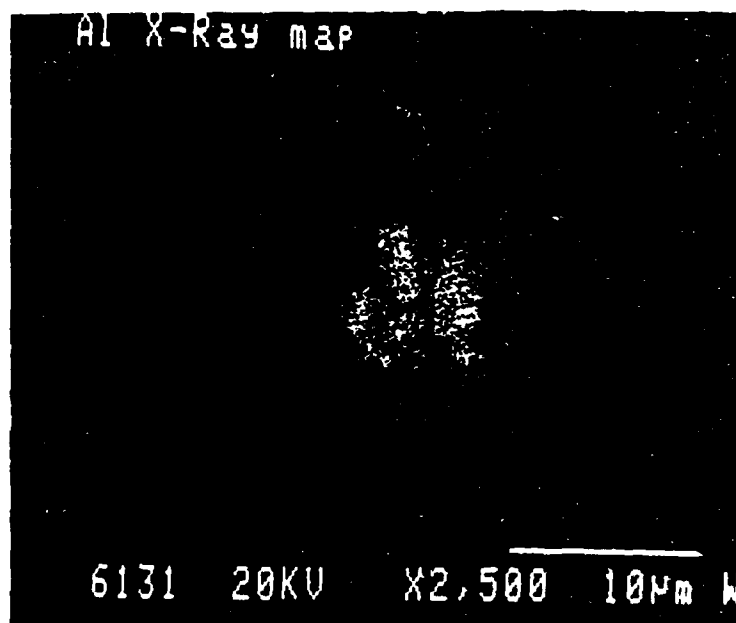
The microscopic evidence provided from this cell clearly suggest that at the potential of about +4V, the reactions occurring in the cell during overcharge are mainly based on corrosion from the cathode. In addition to the V_6O_{13} migration, the Al backing for the cathode is corroding and migrating to the Li surface. This is supported not only from physical observation of the Al, but also from evidence provided by elemental Al analysis. The results also support the conclusion that at this potential neither the electrolyte nor the cathode undergo degradation. This explains the constancy in the potential-time curves during overcharge whereby a simple steady-state corrosion of the Al and vanadium oxide take place.

Figure 14. X - ray mapping of Al on the lithium surface (cell #4).
